Docket No. 217 – Development and Management Plan Inspection

Northeast Utilities Service Company Certificate of Environmental Compatibility and Public Need for the construction of a 345-kV electric transmission line and reconstruction of an existing 115-kV electric transmission line between Connecticut Light and Power Company's Plumtree Substation in Bethel, through the towns of Redding, Weston, and Wilton, and to the Norwalk Substation in Norwalk, Connecticut.

Date: January 12, 2006

Location: Overhead Line (Composite 345kV and 115kV Gallows Hill to Archers Lane) and (345kV H-Frame Hoyts Hill to Gallows Hill)

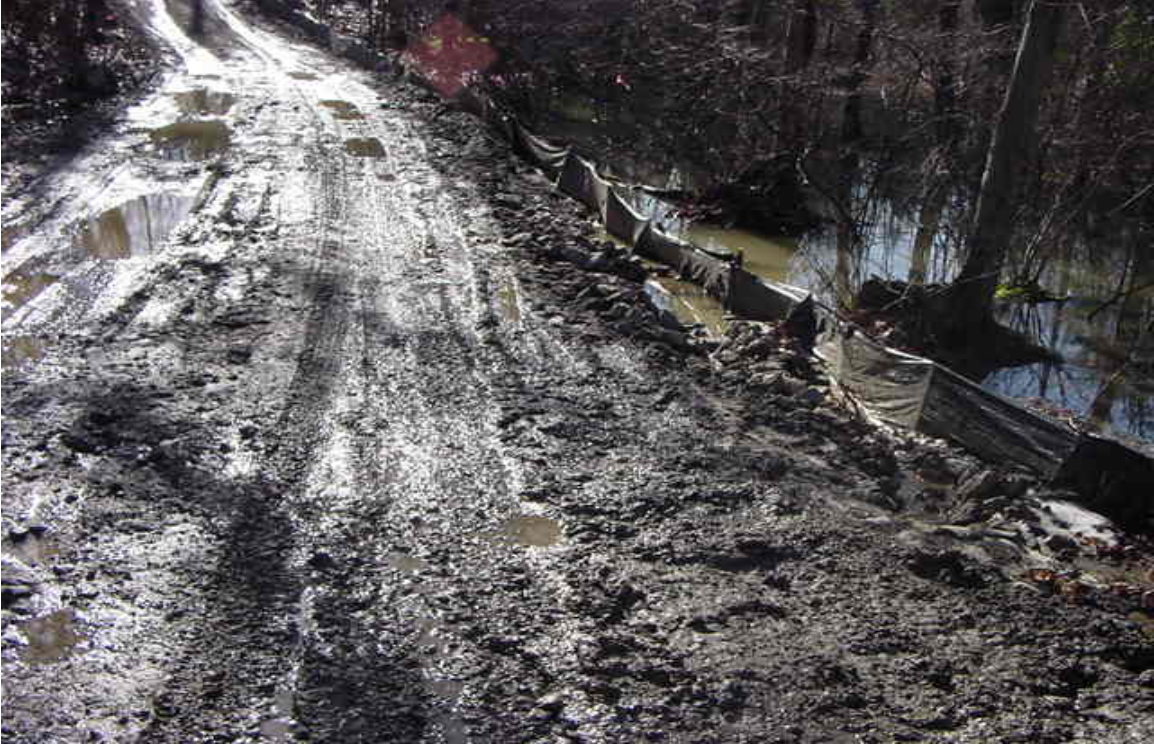
(Composite Section): Photo shows a view of the now muddy access road adjacent to Archers Lane where sediment and turbidity continues to pass through the silt fence to the adjacent wetland. Repairs or a more encompassing solution is necessary. 1/12/06

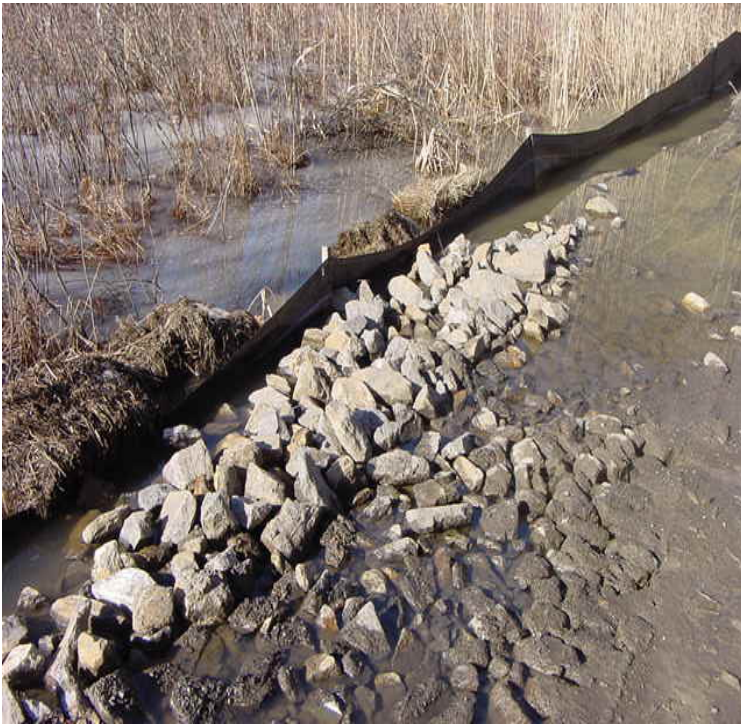
Photo on the left shows the second wetland along the ROW access road where turbid water is pooling against the silt fence. Although some haybales are in place, slightly turbid water was noted in the wetlands. Photo on the right shows the Gallows Hill wetland crossing working well.

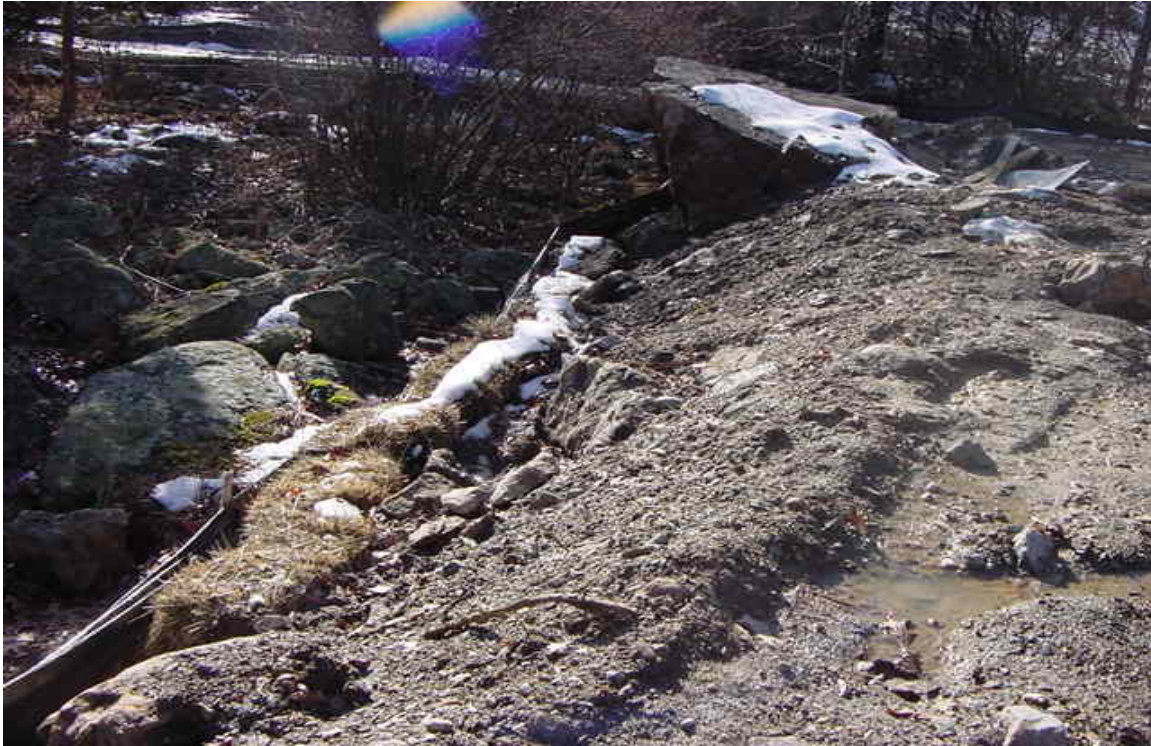
View of the area near the 2nd structure in from Gallows Hill. Bare soil remains piled near the erosion controls. While sedimentation is not an issue at this time and controls are good, the area should be graded to final contours and restored. 1/12/06

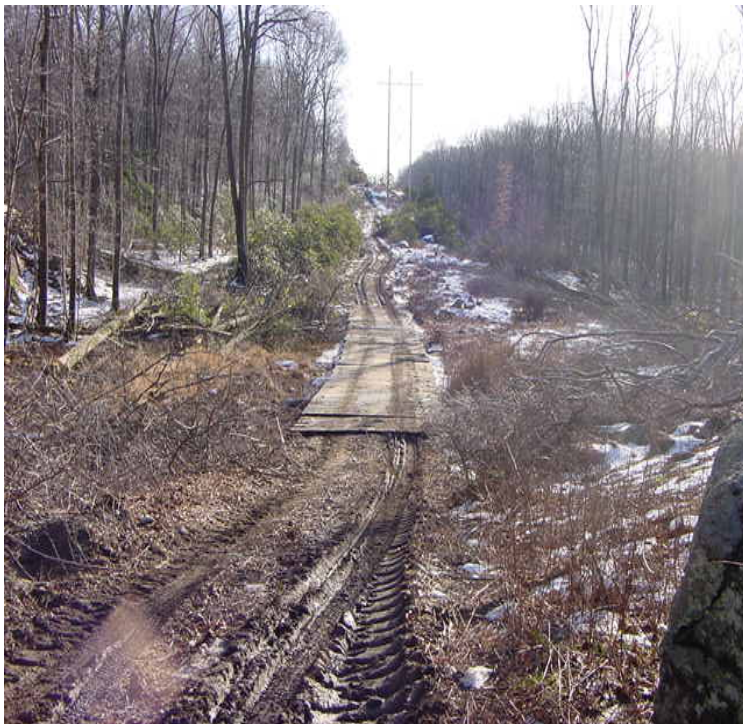
345kV (H-Frame Section): Photo on the left shows where mats were installed at the larger wetland crossing near the Bethel Reservoir land. Photo on the right shows the structure where clearing and the access road had reached. Erosion controls were recommended here. 1/12/06

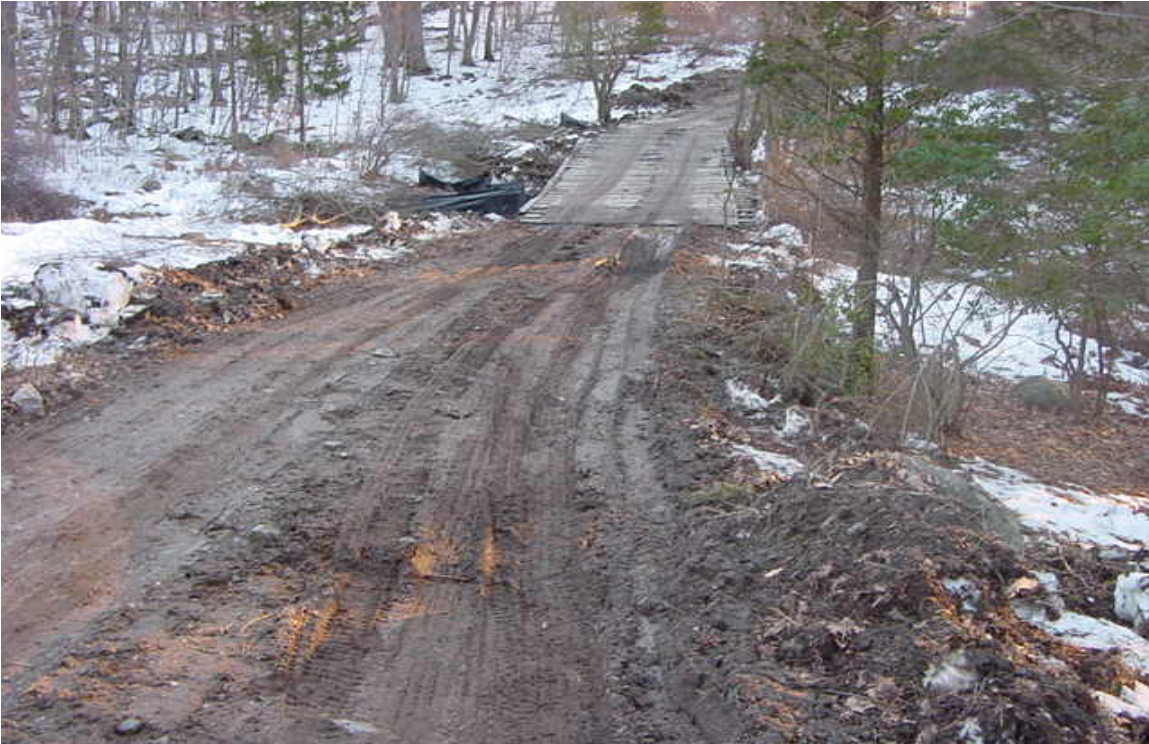
View of mats installed over a wetland crossing located between Hoyts Hill and Chestnut Ridge Rd. Silt fence check dams were installed as recommended but some areas weren't toed-in. We also recommend more areas of fence on either side of the crossings to keep sediment from the access road out. 1/12/06

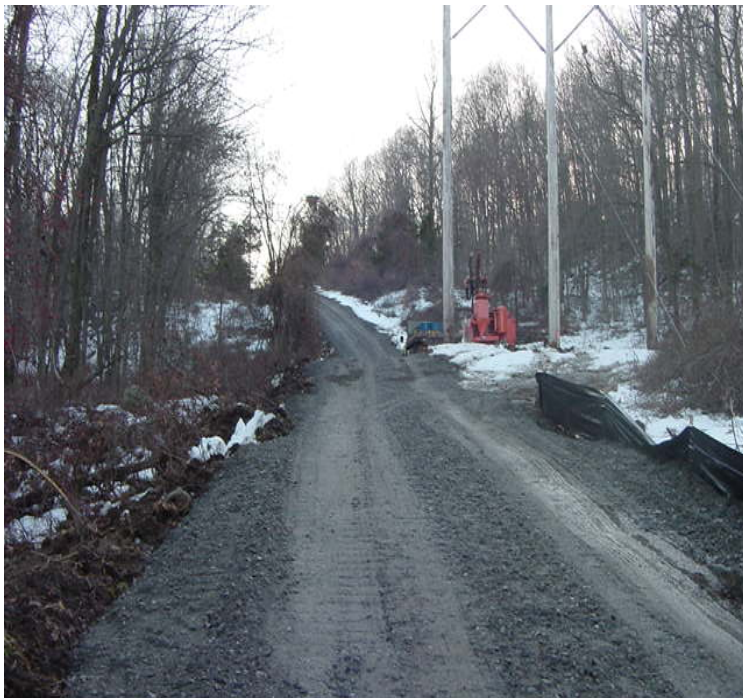
Photo on the left is a view of the access road constructed for continuing work on the ROW. Some areas of silt fence need to be toed-in properly. Photo on the right shows active drilling for structure foundations in this section. 1/12/06
